Job name: Inspect Weir Flow Plate, Screen Mesh & Replace Floor 1.5

Description: Remove and Re-Install Insulation Lagging

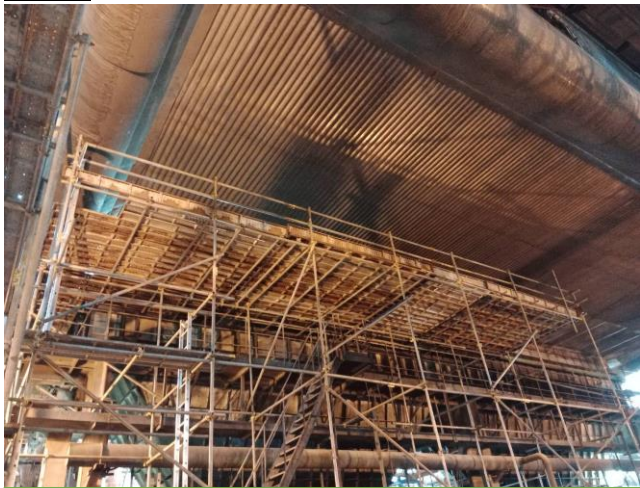
Before

- ปริมาณ 106 m2
