# **Report**

***Remove and Re-installation Insulation Lagging Line Pipe  
Turbine Unit.1 Floor.2***

***Location  
Turbine Unit.1 Floor.2***

***Owner  
Hongsa Power***

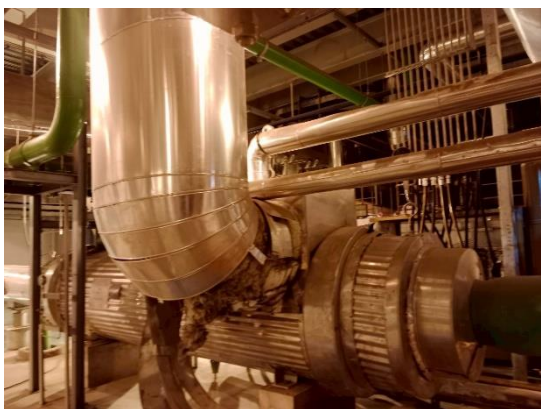
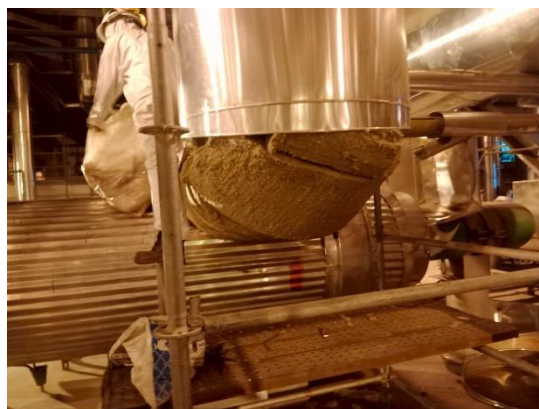
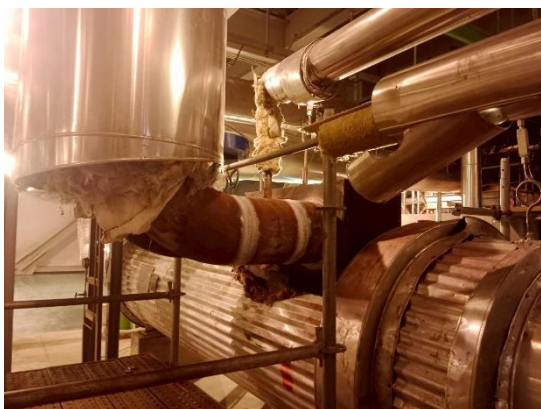
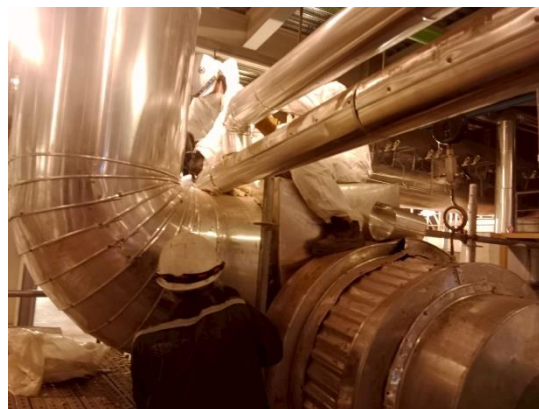
*Description: Remove and Re-installation Insulation Lagging*
