***Remove and Re-Installation Insulation Lagging Line pipe  
Turbine 1 Extraction Steam Pipe Top Turbine Unit.2 Floor.2***

***Turbine Unit.2 Floor2***

***Hongsa Power***

***0120 RP120/25***

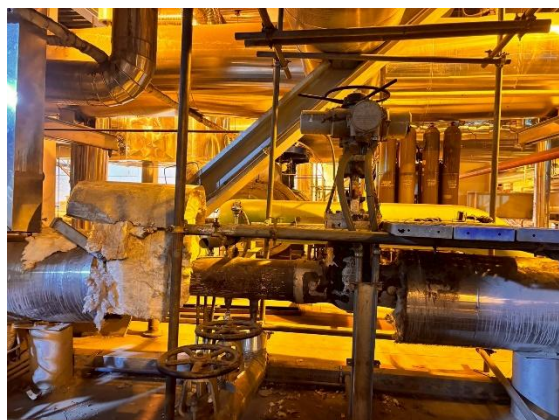
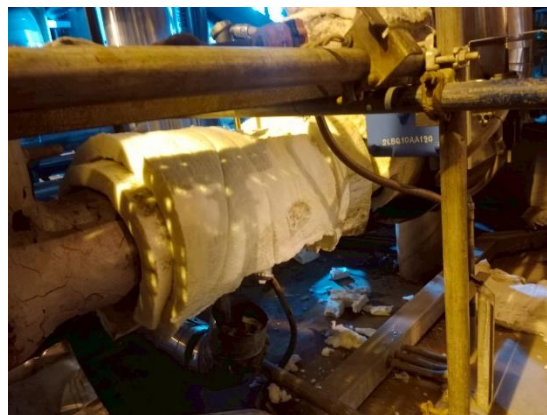
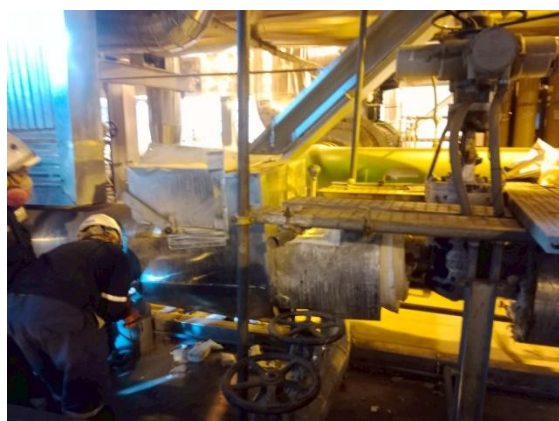
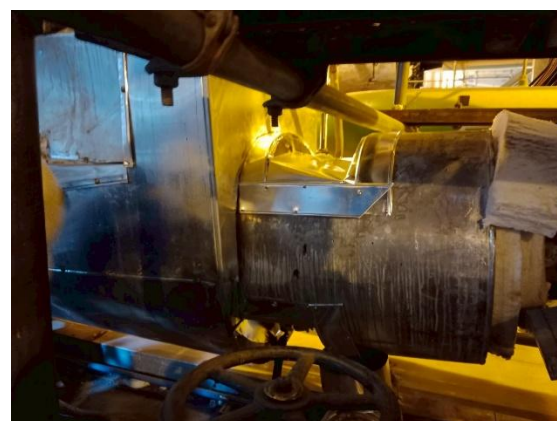
*Description: Remove and Re-Installation Insulation Lagging*
