Daily Report

Job name: Expansion Joint Booster Fan A

Date: 16/01/2024

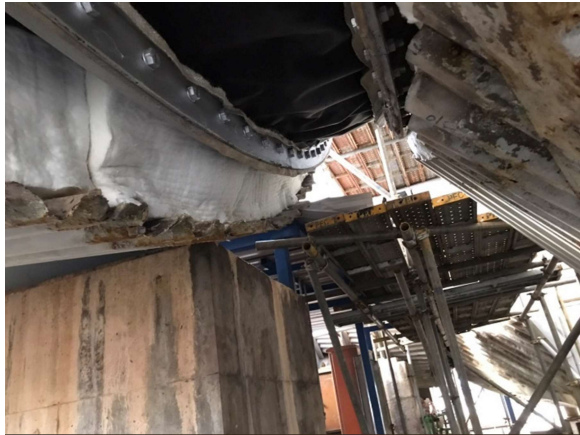
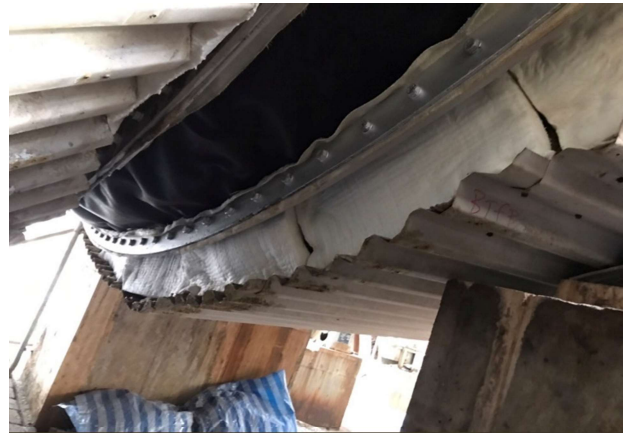
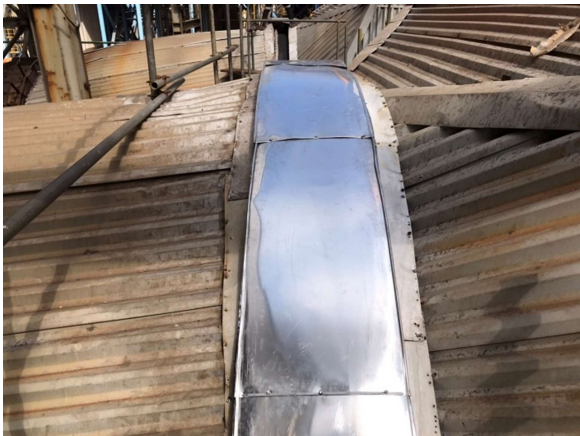
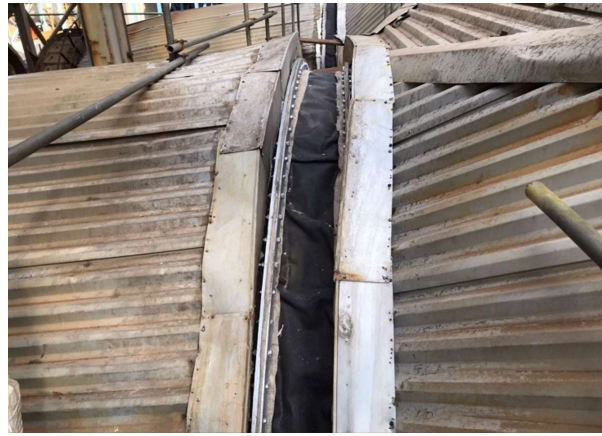
Description: Installation Insulation and Lagging 100%

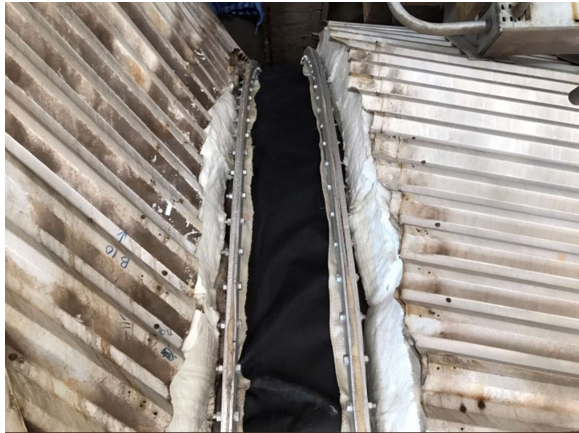
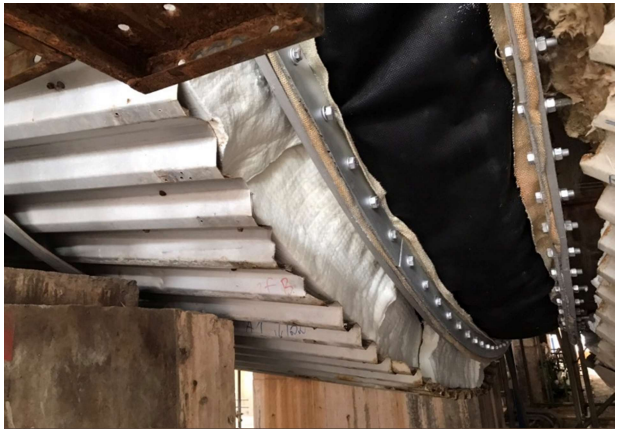
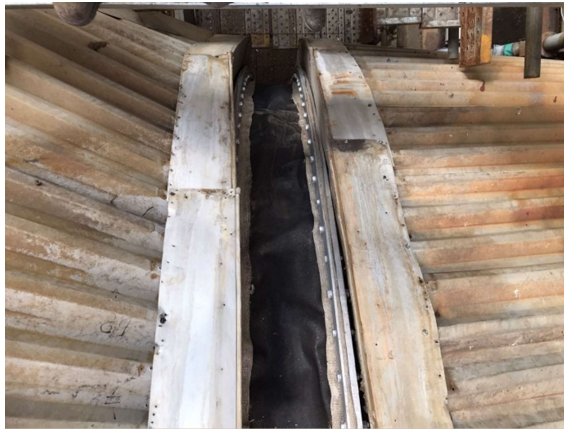
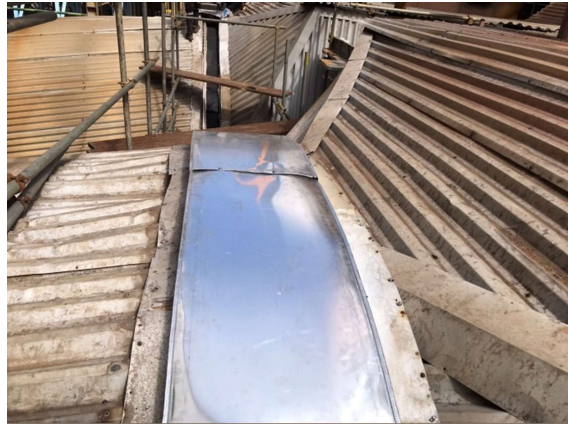
Job name: Expansion Joint Booster Fan B

Description: Installation Insulation and Lagging 100%

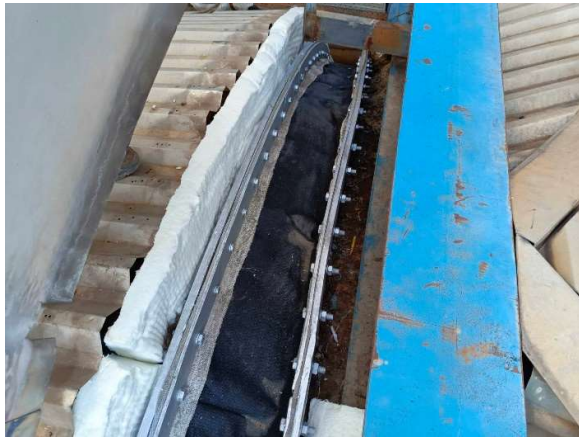
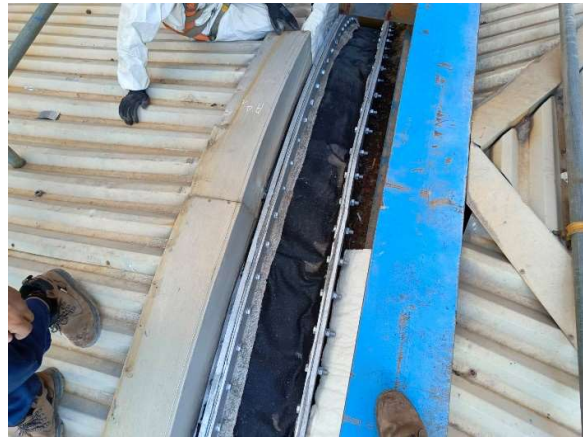
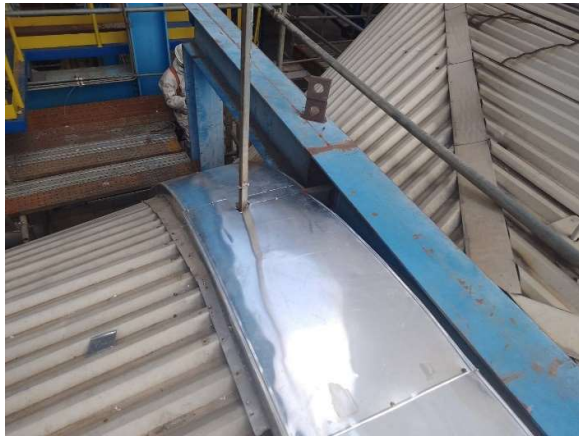
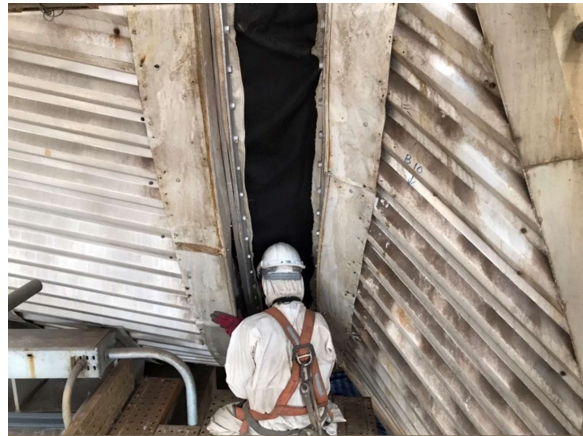
Job name: Expansion Joint ID Fan B

Description: Installation Insulation and Lagging 100%

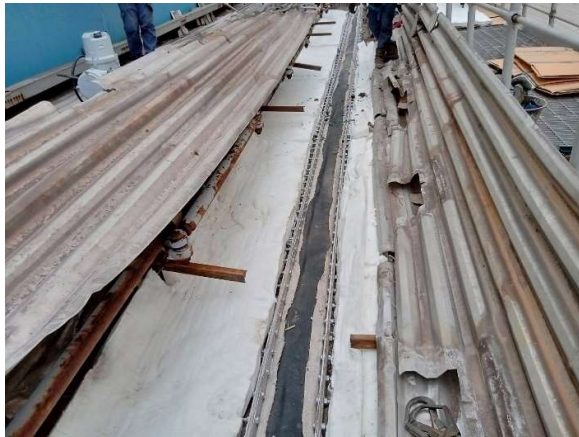
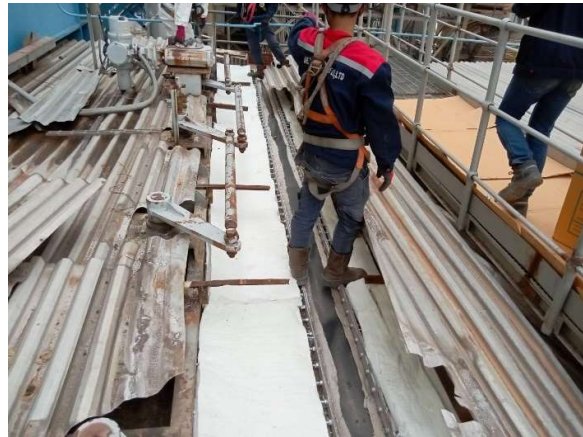
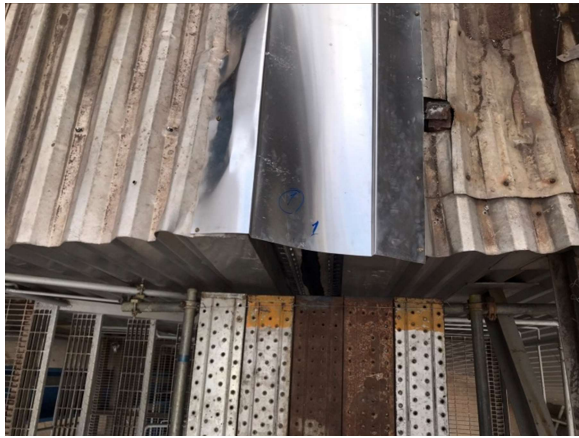
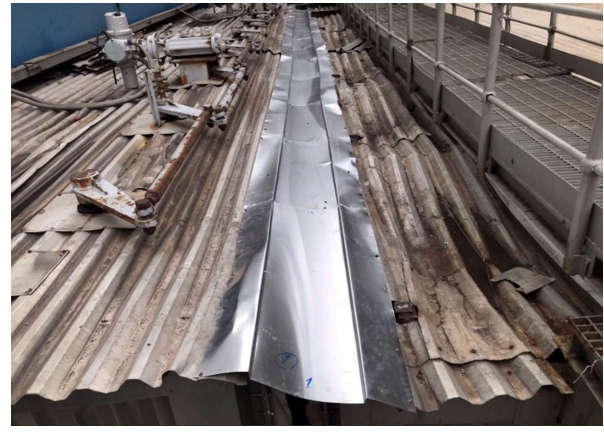
Job name: Expansion Joint Outlet FGD

Description: Installation Insulation and Lagging 100%

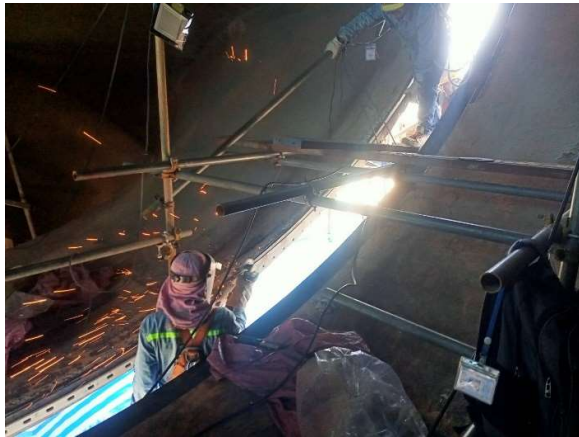
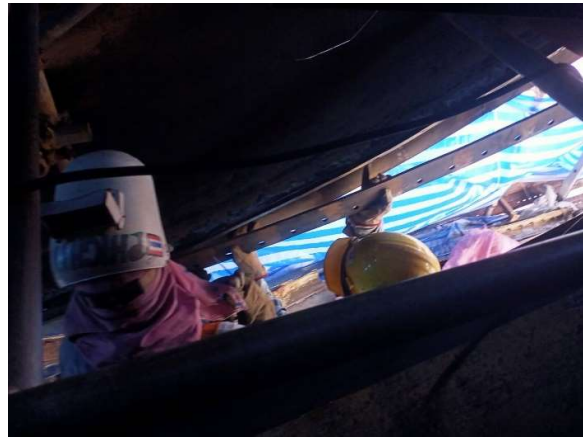
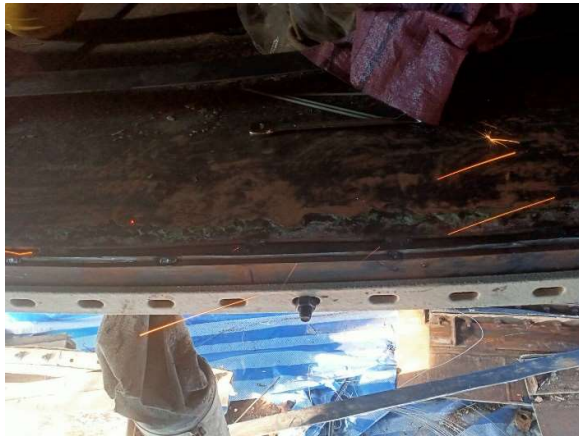
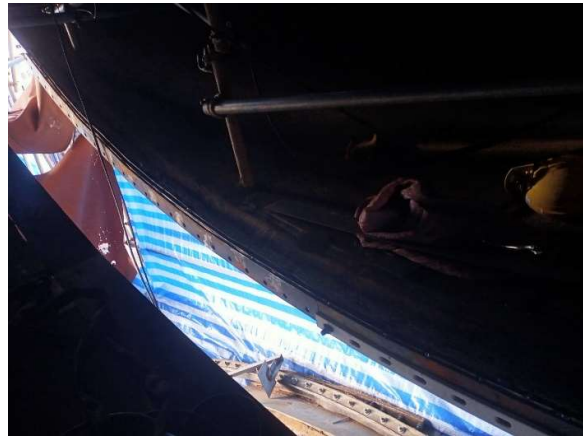
Job name: Expansion Joint Absorber Outlet to Clean Gas

Description: Installation Expansion Joint Frame 60%

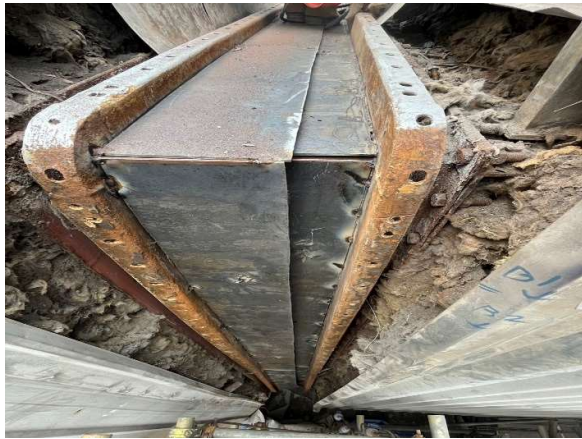
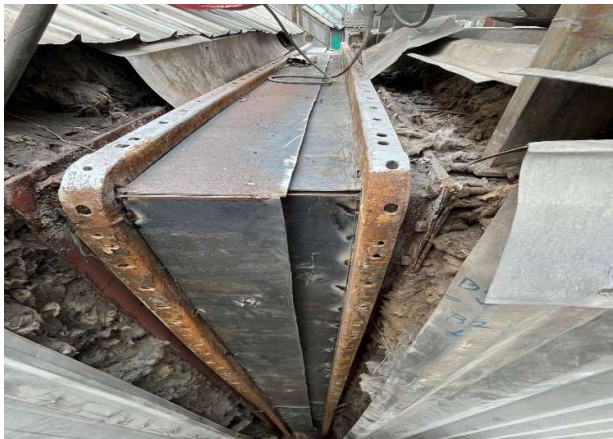
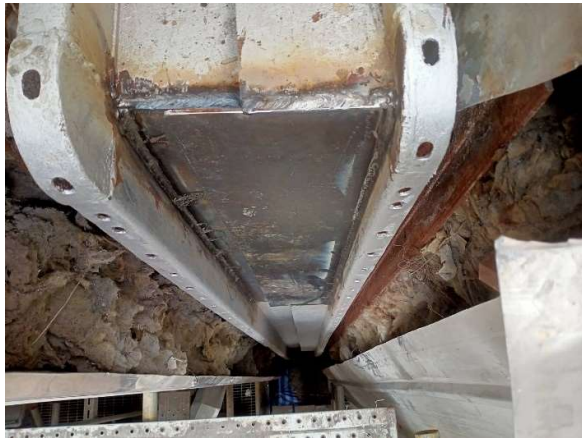
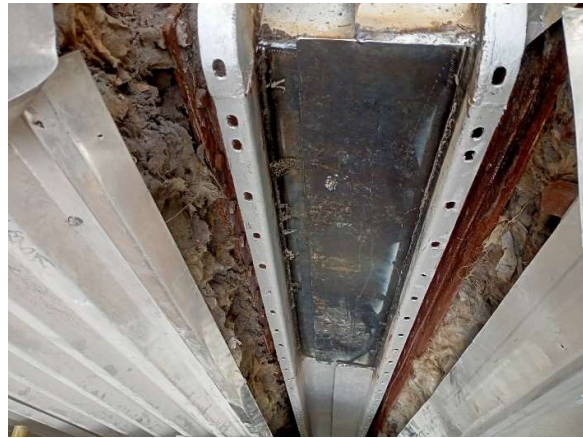
Job name: Expansion Joint Inlet ESP No.2

Description: Repair Liner 80%

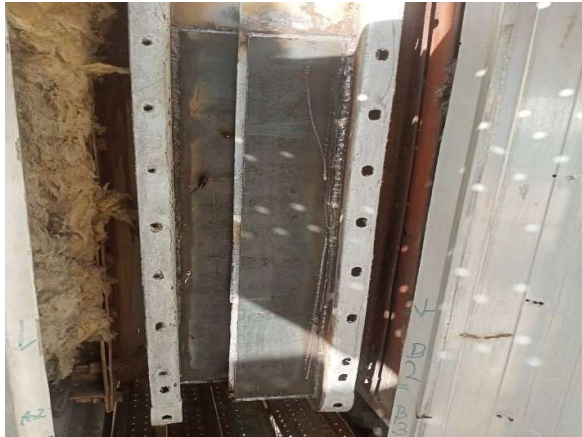
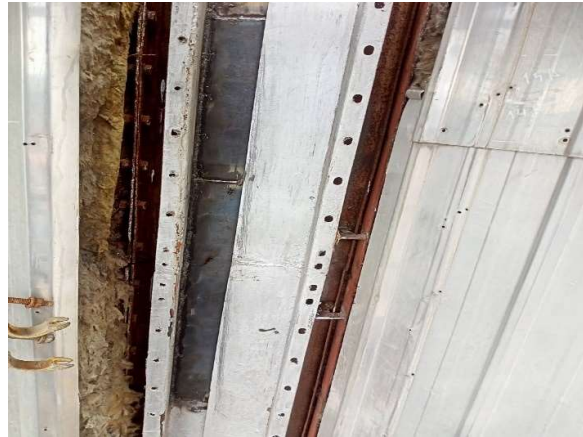
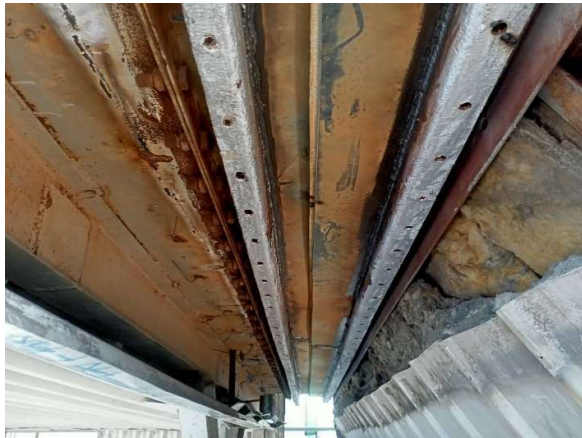
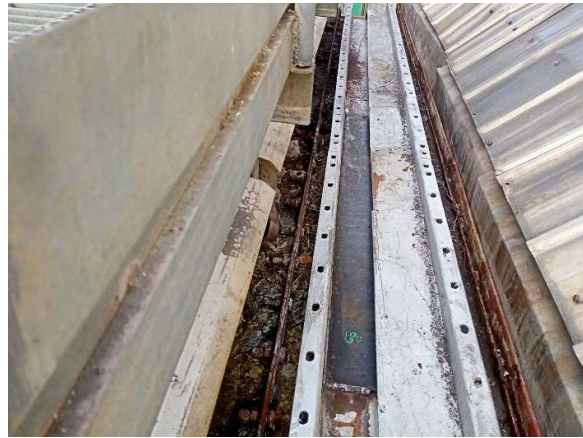
Job name: Expansion Joint Inlet ESP No.6

Description: Repair Liner 80%

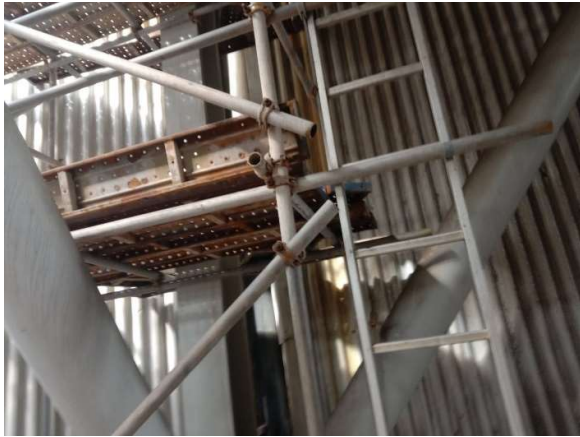
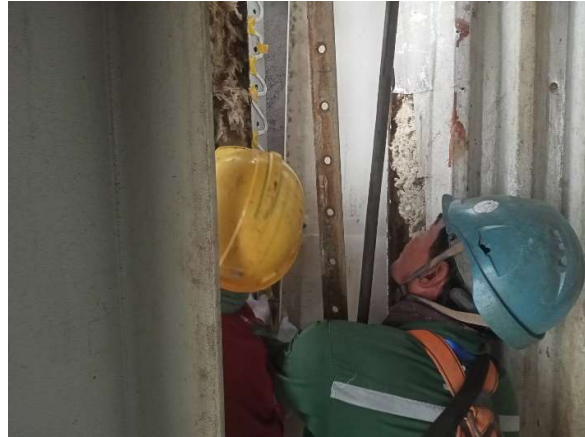
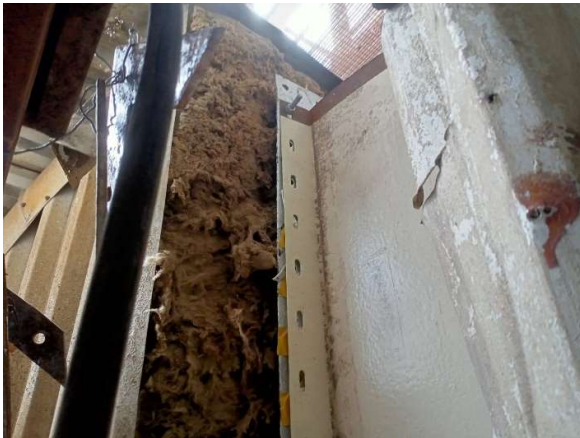
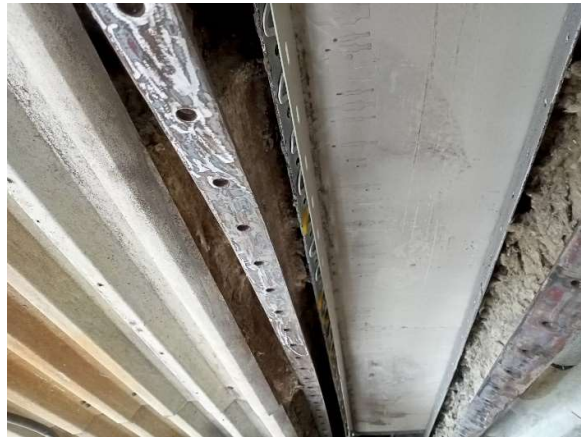
Job name: Expansion Joint Outlet BUF

Description: Installation Liner 100%

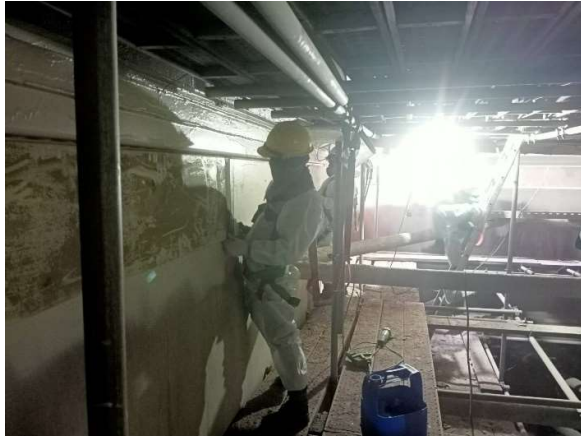
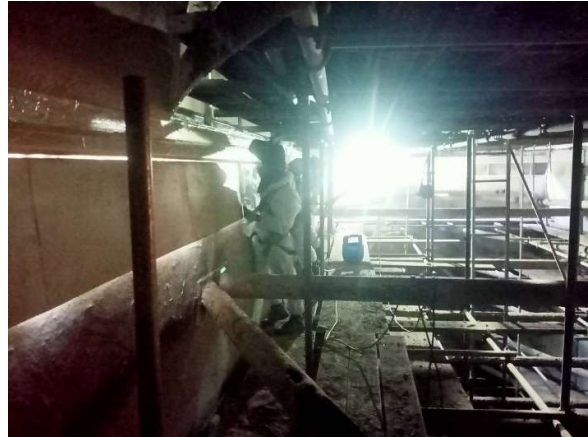
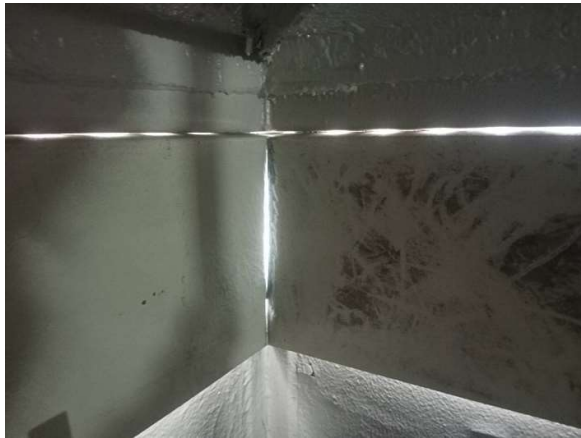
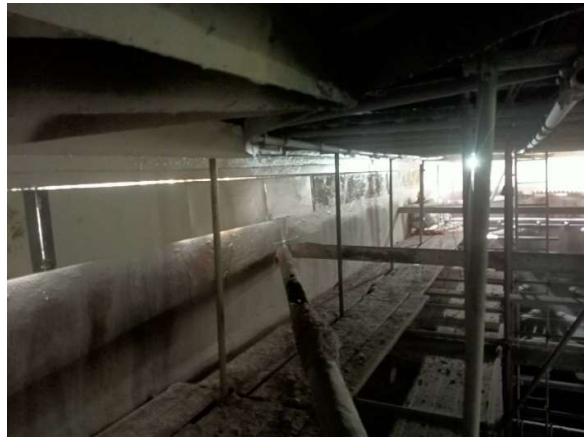
Job name: Expansion Joint Outlet Clean Gas

Description: Installation Liner 80%
