Daily Report

Job name: Expansion Joint Inlet ESP No.2

Date: 22/01/2024

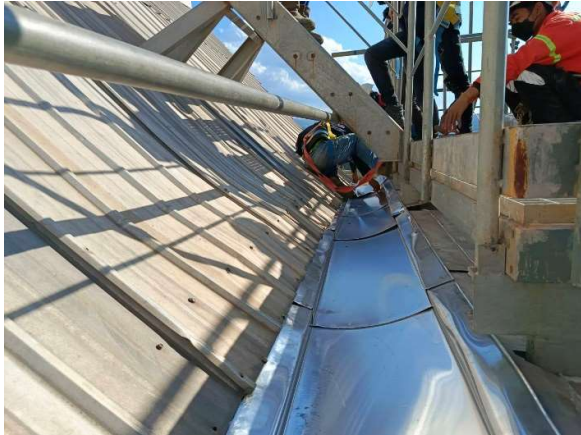
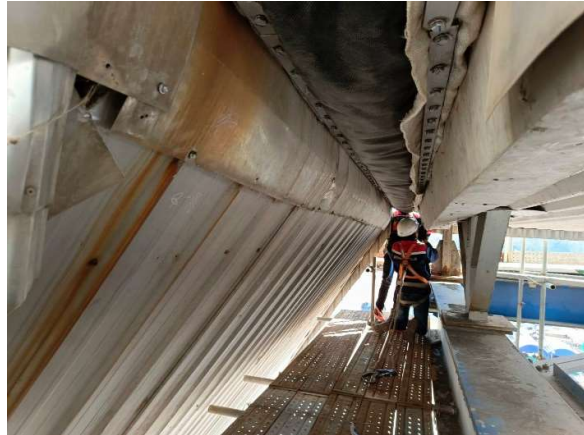
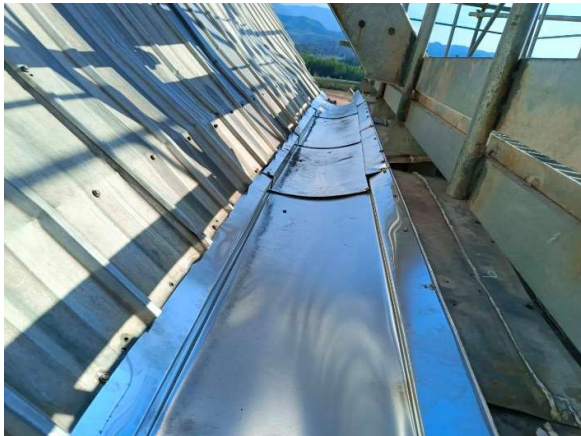
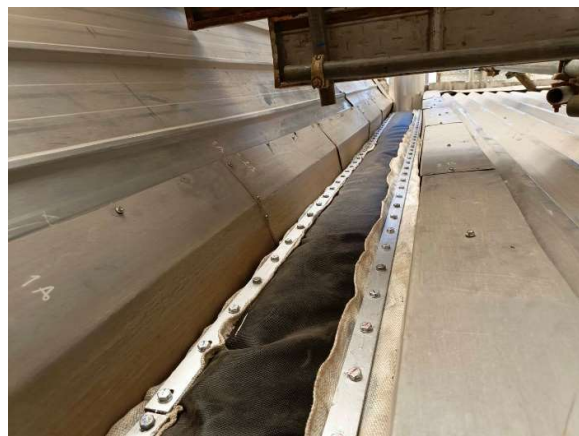
Description: Installation Insulation Lagging 100%

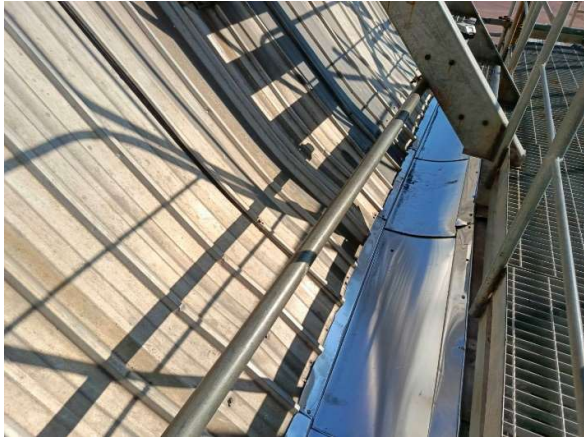
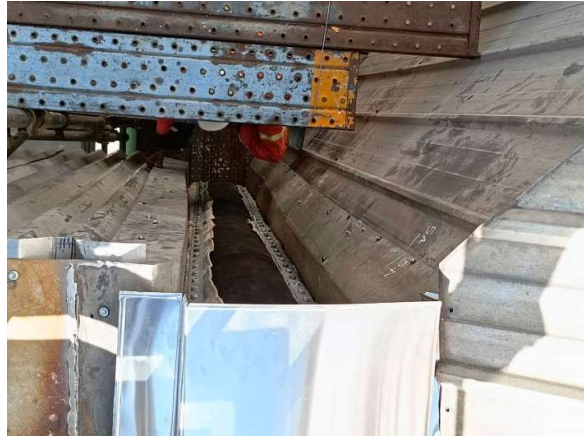
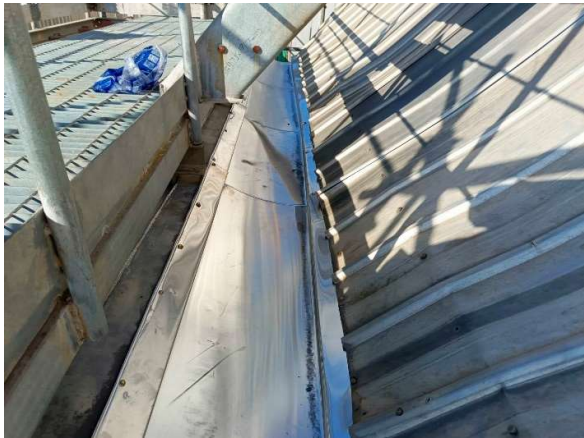
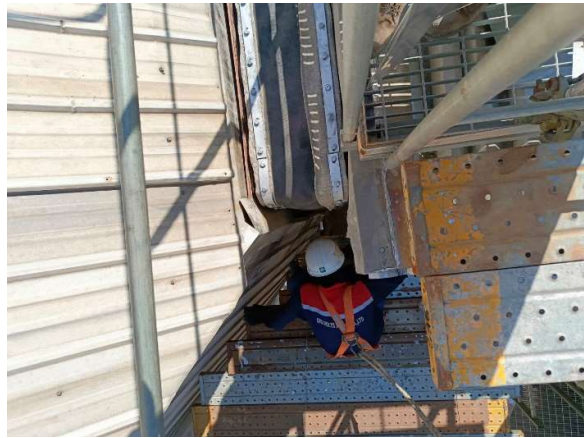
Job name: Expansion Joint Inlet ESP No.6

Description: Installation Insulation Lagging 100%

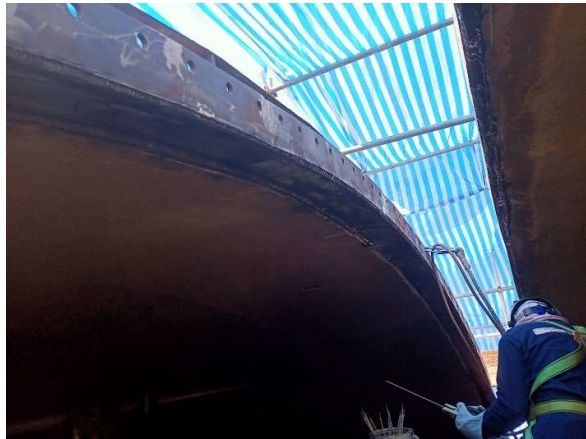
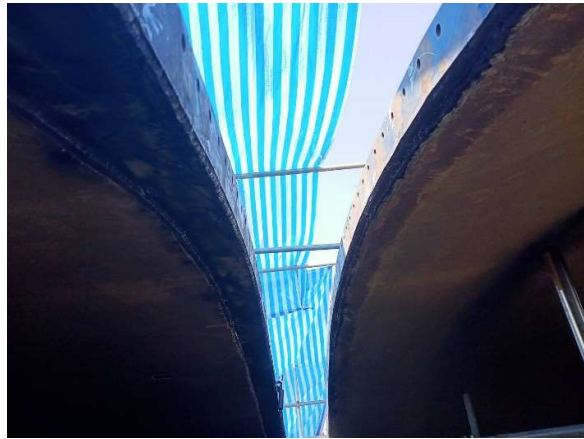
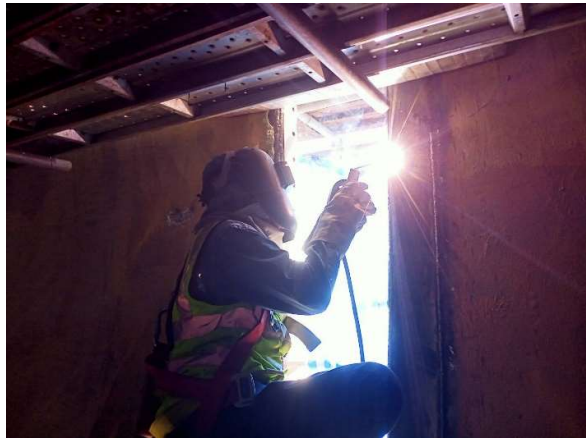
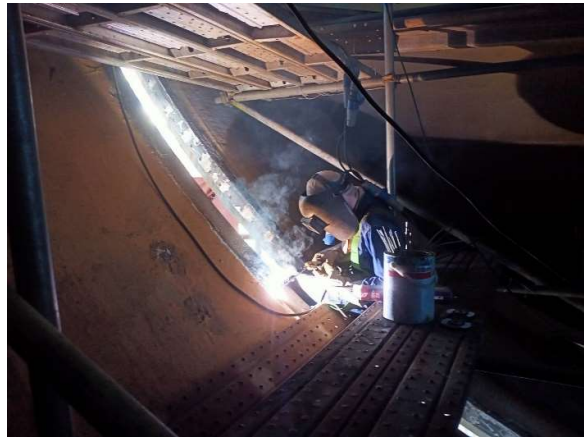
Job name: Expansion Joint Absorber Outlet to Clean Gas

Description: Installation Expansion Joint Frame 90%

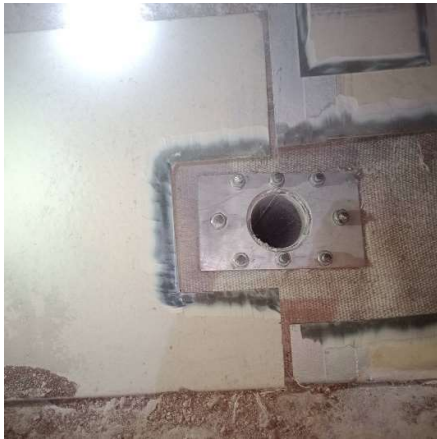
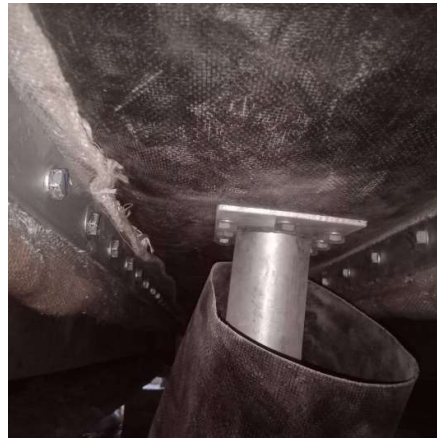
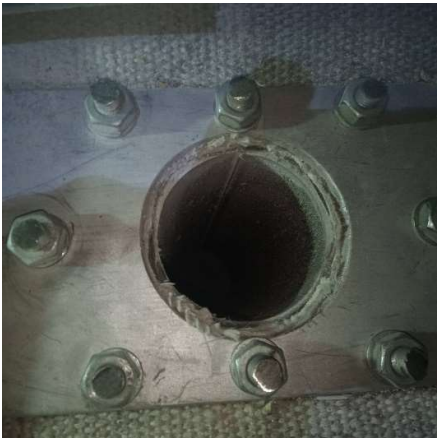
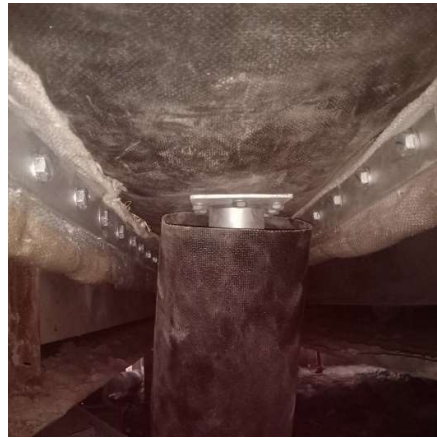
Job name: Expansion Joint Outlet BUF

Description: Installation Line Drain 80%

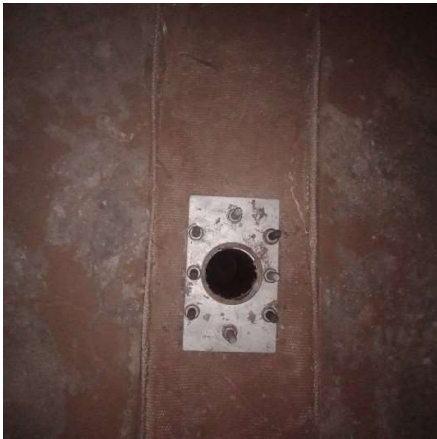
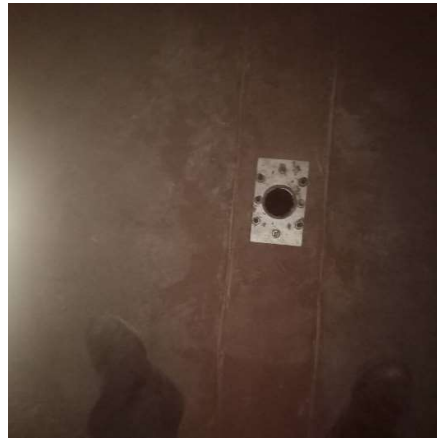
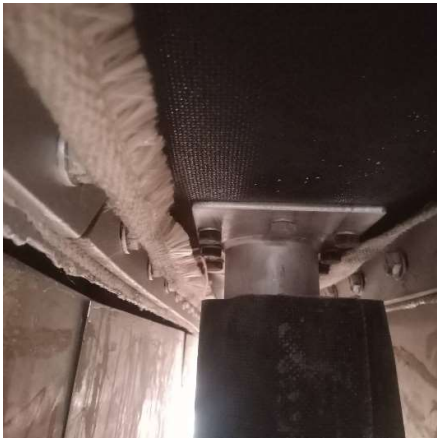
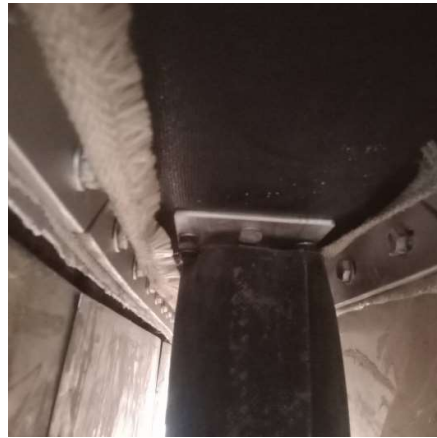
Job name: Expansion Joint Outlet FGD

Description: Installation Line Drain 80%
